# Low-Carbon Campus: Exploring Universiti Malaysia Sarawak's Pedestrian Walkways as Tools for Sustainable Mobility

Universiti Malaysia Sarawak (UNIMAS) developed the UNIMAS Low-Carbon Campus Roadmap 2030, a sustainable blueprint aimed at encouraging staff, lecturers, and students to actively lower their carbon emissions. Through the roadmap's strategic actions, UNIMAS seeks to significantly reduce greenhouse gas emissions, particularly carbon dioxide, from key operations such as transportation, waste management, and energy consumption (*UNIMAS Low-Carbon Roadmap 2030*, 2023).

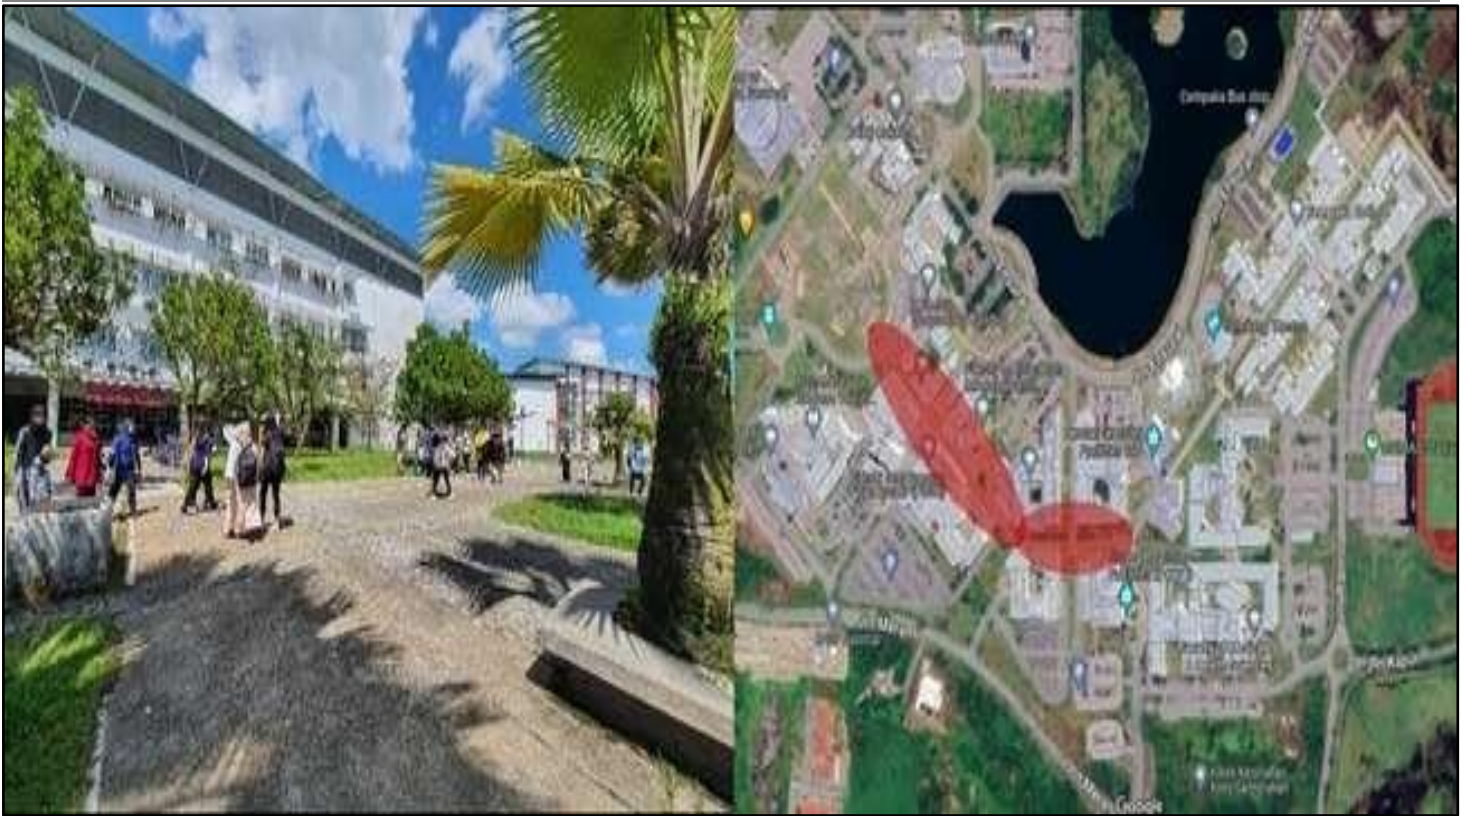
Figure 1: Pedestrian walkway in between buildings from Central Teaching Facilities 2 (CTF 2) to Tun Abdul Rahman Ya'kub Library (PeTary) (Source: Author and Google Earth)

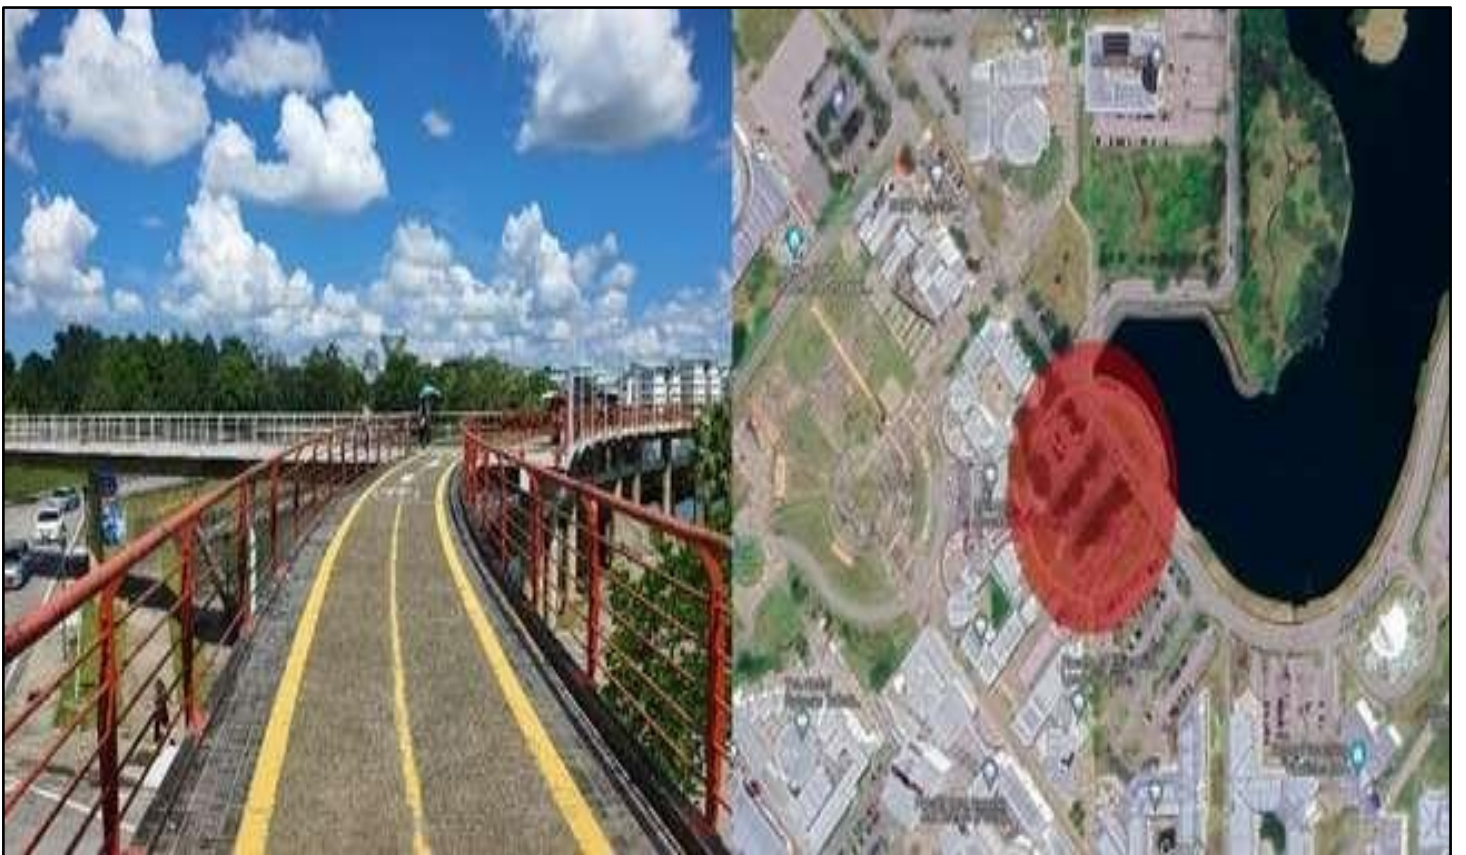
Figure 2: Pedestrian bridge (Source: Author and Google Earth)

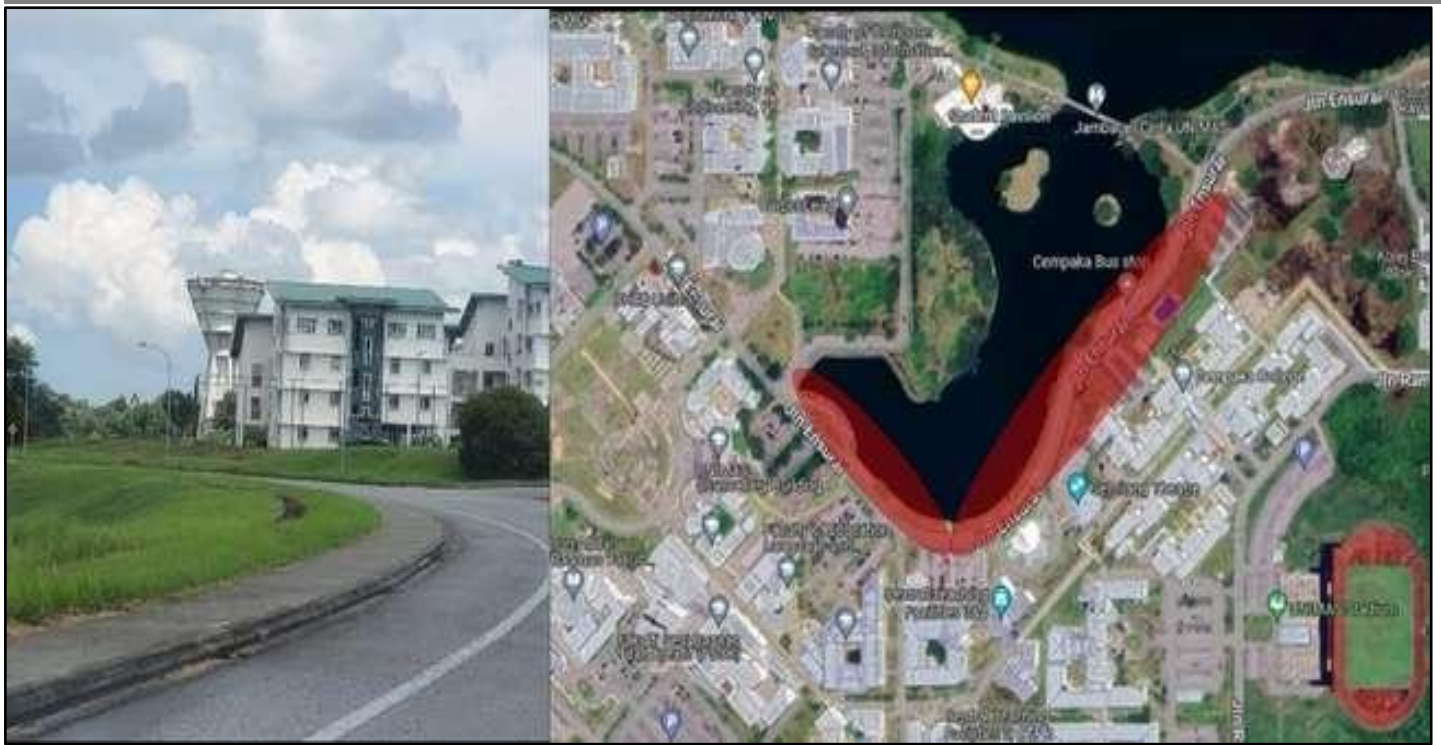
Figure 3: Pedestrian walkway (sidewalk) near road and next to UNIMAS lake

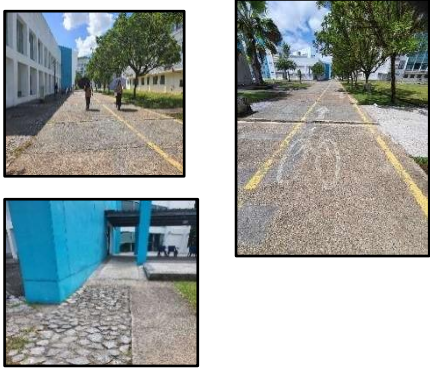
| Criteria | Characteristic | Pictures |
|---|---|---|
| Accessibility | <ul style="list-style-type: none"> <li>The pathway is designated for pedestrians, as well as bicycles and e-scooters.</li> <li>It features a 3.5-meter-wide walking lane and a 2.5-meter-wide lane for bicycles and e-scooters.</li> <li>The pathway is highly accessible, directly connecting to faculties located along the campus spine.</li> <li>However, it lacks tactile surfaces to assist individuals with visual impairments.</li> <li>The stony surface presents challenges for wheelchair users due to its unevenness.</li> </ul> | |

| Issues | Potential improvement |
|---|---|
| 3. The walkway surface is made of rocky material that is uncomfortable to walk on and unsuitable for wheelchair users. | To change out the stony surface with more levelled surface. |
| 4. Lack of a tactile surface for those who are visually impaired. | To introduce tactile surface on the current walkway for pedestrians. |

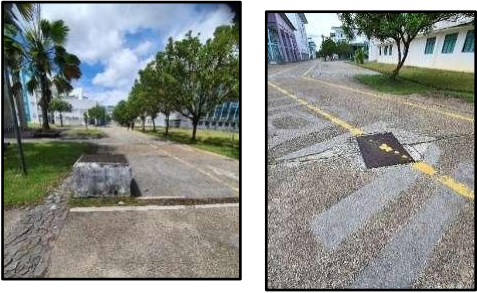
| Criteria | Characteristic | Pictures |
|---|---|---|
| Safety and Security | <ul style="list-style-type: none"> <li>No major obstacle on the pathway except for one manhole that is position upright (manhole cover not flush with pedestrian surface).</li> <li>some manhole has uneven surfaces surrounding them.</li> <li>There is roughly one lamp post for every 15 meters on each side of the pedestrian area. However, significant number of these lamp posts are not functioning properly, resulting in a poorly illuminated pedestrian pathway at night.</li> </ul> | |

| Issues | Potential improvement |
|---|---|
| 2. Not enough light. The location has a number of malfunctioning light posts, which makes the pedestrian walkway dimly lit at night. | To improve pedestrian lighting by considering LED and solar power. |

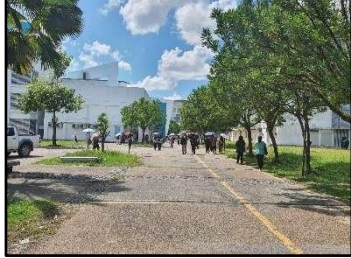
| <b>Comfortability</b> | <ul style="list-style-type: none"> <li>• The footpath surface is made of exposed aggregate concrete, which is firm and skid resistant.</li> <li>• Every 13 meters interval of the pedestrian, there is strip of stony surface with 1-meter width. This stony surface is not comfortable to step on.</li> <li>• A paving drainage channel, 100 mm wide, is placed every 6 meters, but uncovered sections create gaps that disrupt the walking experience. Currently many debris and dry leaves accumulated in the channel which not let the water flow out smoothly.</li> <li>• The pedestrian walkway has areas with cracked surfaces and holes, further impacting usability.</li> <li>• The walkway lacks a roof, and while trees are planted along the spine, they are not large enough to provide adequate shade.</li> </ul> | |

| Issues | Potential improvement |
|---|---|
| 1. There was no roof over this pedestrian path, so students had to use umbrellas to protect themselves from the rain and hot weather. | This path serves as a service road in addition to a pedestrian promenade, thus building a roof over the service road could be challenging. Therefore, when it becomes necessary to open the area for maintenance and to let a vehicle in, the roof will be retractable and able to be opened. The roof should be at least six meters above the ground. |

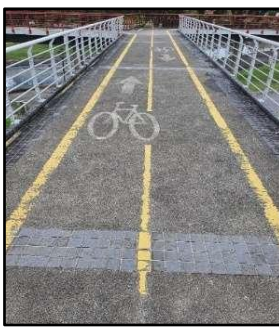
| Criteria | Characteristic | Pictures |
|---|---|---|
| <b>Accessibility</b> | <ul style="list-style-type: none"> <li>• This bridge connects the northern and southern sections of UNIMAS West Campus.</li> <li>• The walkway is relatively narrow, making it challenging to share with bicycles and e-scooters, with the design appearing more dedicated for bicycles and e-scooters than pedestrians.</li> <li>• The pathway lacks tactile surfaces to guide visually impaired individuals.</li> </ul> | |

| Issues | Potential improvement |
|---|---|
| 4. Lack of a tactile surface for those who are visually impaired. | To introduce tactile surface on the current walkway for pedestrians. |

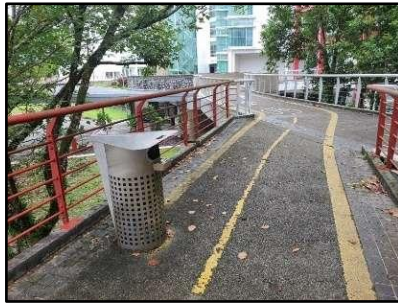
| Criteria | Characteristic | Pictures |
|---|---|---|
| <b>Safety and Security</b> | <ul style="list-style-type: none"> <li>• The pathway is generally clear, except for three dustbins placed at certain points on the pedestrian bridge, requiring pedestrians and cyclists/e-scooter users to navigate around them.</li> <li>• The bridge lacks dedicated lighting, relying solely on streetlights for illumination.</li> <li>• Pedestrians share the narrow pathway with bicycles and e-scooters, exposing them to potential hazards due to the close proximity of these users.</li> </ul> | |

| Issues | Potential improvement |
|---|---|
| 2. Not enough light. The location has a number of malfunctioning light posts, which makes the pedestrian walkway dimly lit at night. | To improve pedestrian lighting by considering LED and solar power. |

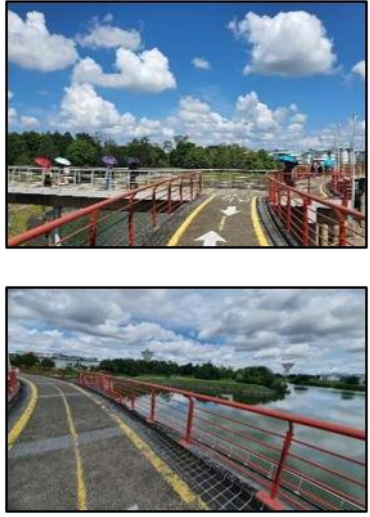
| <b>Comfortability</b> | <ul style="list-style-type: none"> <li>• The footpath surface is constructed from firm, even, and skid-resistant material.</li> <li>• The pedestrian bridge lacks a roof, leaving users exposed to hot weather and rain.</li> <li>• The bridge offers pedestrians a scenic view of the UNIMAS lake while walking.</li> </ul> | |

| Issues | Potential improvement |
|---|---|
| 1. There was no roof over this pedestrian path, so students had to use umbrellas to protect themselves from the rain and hot weather. | To add roof and make it a covered walkway. |

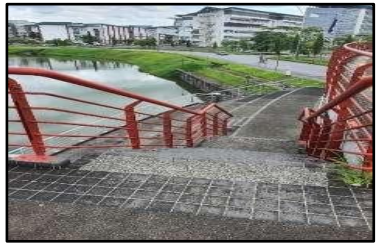
| <b>Connectivity</b> | <ul style="list-style-type: none"> <li>• In addition to connecting the northern and southern parts of UNIMAS West Campus, the bridge provides access to the Chancellery building and features staircases leading down to the amphitheatre overlooking the lake.</li> </ul> | |

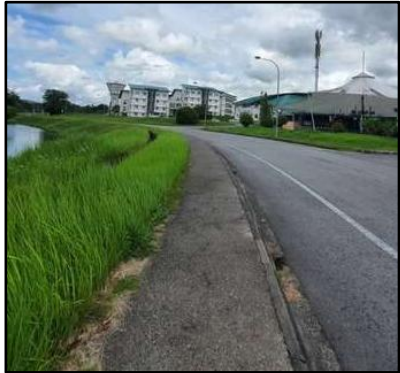
| Criteria | Characteristic | Pictures |
|---|---|---|
| <b>Accessibility</b> | <ul style="list-style-type: none"> <li>• The pedestrian walkway lacks a dedicated lane for bicycles or e-scooters. However, observations indicate that some students occasionally use this pathway for riding, which, given its 1.5-meter width, can lead to congestion with pedestrians.</li> <li>• The walkway does not include tactile surfaces for visually impaired individuals, nor are ramps provided, limiting accessibility.</li> </ul> | |

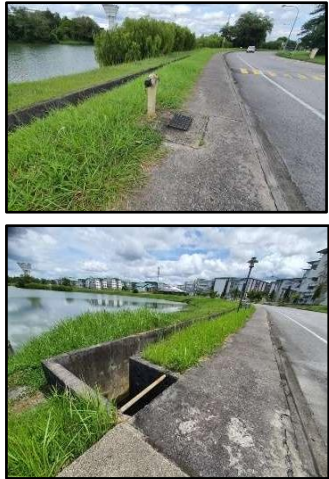
| Criteria | Characteristic | Pictures |
|---|---|---|
| <b>Safety and Security</b> | <ul style="list-style-type: none"> <li>• A manhole cover near the fire hydrant is not flush with the pathway surface, posing a potential tripping hazard.</li> <li>• Certain sections of the walkway run directly alongside an open drain, creating a safety risk if pedestrians were to fall.</li> <li>• Streetlamps are provided for the first 200 meters of the walkway but do not extend to its entire length, resulting in inadequate lighting and a poorly illuminated pathway at night.</li> </ul> | |

| 4. There is an area of the walkway that is highly unsafe for pedestrians to fall into because it is right near to an exposed drain. | To install a wall barrier or cover the drain between the drainage and the pedestrian walkway. |

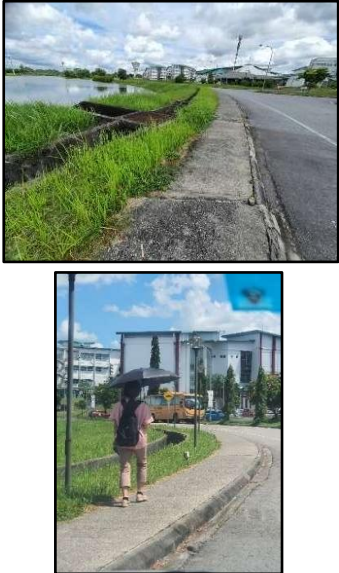
| <b>Comfortability</b> | <ul style="list-style-type: none"> <li>• Certain sections of the walkway have unintended changes in level caused by damage, impacting its usability and safety.</li> <li>• The pedestrian walkway is uncovered, leaving users exposed to hot weather and rain, requiring students to use umbrellas for protection.</li> </ul> | |

| 6. The pathway surface is generally even, however in certain places there are unintentional level differences that mostly damage related. | To fix the cracked and unevenness on the pedestrian walkway. |

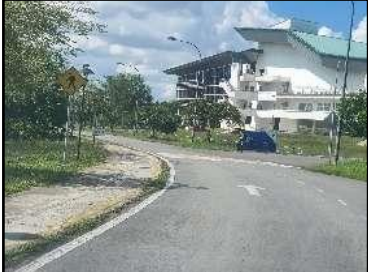
| <b>Connectivity</b> | <ul style="list-style-type: none"> <li>• This pedestrian walkway connects to other walkways that lead to different areas of UNIMAS which is towards the lake Suspended Bridge and Pusat Islam UNIMAS (PITAS).</li> </ul> | |
