The Convergence of Record Rainfall, Anthropogenic Destabilization, and Overlooked Geomorphological History: A Systematic Review of the 2022 Tupul Landslide

Kosygin Leishangthem

Assistant Professor, Manipur Technical University

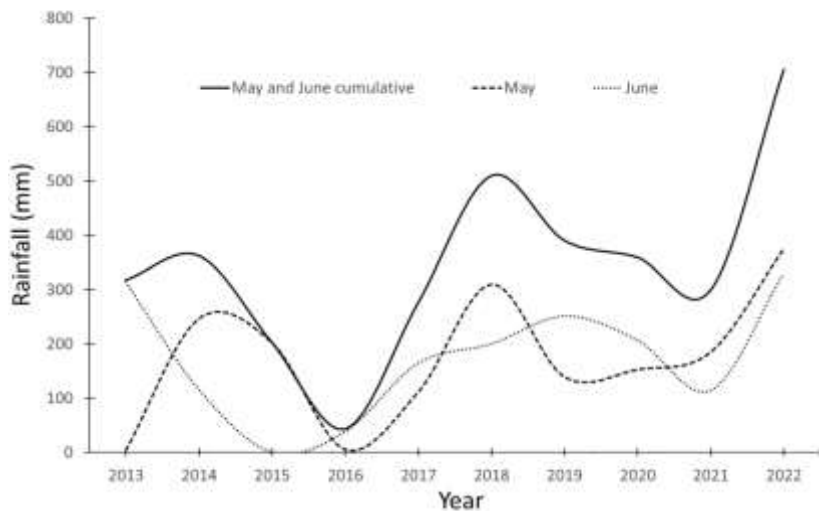
Figure 2: Rainfall Intensity and Cumulative Precipitation Graph.

Description: A graph comparing the June 2022 rainfall (which was 130% higher than the decadal average) against the 2012–2021 baseline. Adapted from [2].

The 2022 Tupul landslide was not caused by a single event but was the result of a combined effect of extreme meteorological events and geological fragility, coupled with intensive anthropogenic modifications. The primary trigger was an intense monsoon event, as rainfall during June 2022 was nearly 130% above the average annual rainfall recorded over the last 10 years (2012–2021) [2]. High intensity precipitation over an 11-day period of continuous rainfall [3] caused a large amount of moisture to infiltrate into the slope, resulting in an increase in pore-water pressure and a decrease in the shear strength of the soil and rock interface, causing the slope to move into a critical state of failure [1], [3]. The failure occurred in two well-defined, discrete stages: the first at 12:30 AM and the second at 6:00 AM on June 30th [2].

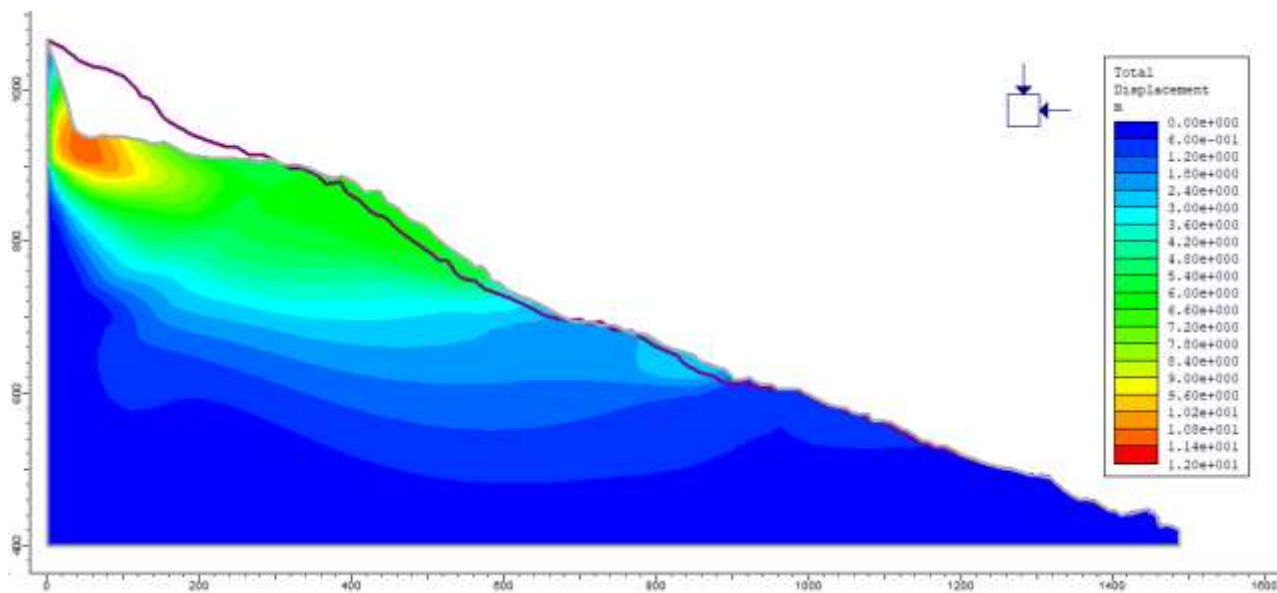
Figure 3: Cross-Section and Finite Element Analysis Modeling by

Description: A diagram showing the slope's factor of safety before and after the "yard-cutting" modifications. Adapted from [1].

Human interventions drastically reduced the natural factor of safety of the hillslope, and the most important of these was the "yard-cutting" of the toe of the slope to make it a flat area for the Tupul railway station [1]. This removal of the structural base along with massive deforestation for railway construction removed the natural mechanical reinforcements of the slope [1], [2], confirmed by engineering analysis using Finite Element Methods [1]. The resulting mass movement destroyed 435 to 500 m of the under-construction railway line, buried the railway yard, and blocked the Ijai River, forming a temporary hazard lake that immediately threatened downstream populations with a flood [2], [3].

At the same time, the "yard-cutting" modifications to create a platform for the Tupul railway station had eliminated the "toe" of the slope, which is the natural structural buttress of the hillside, and the factor of safety of the slope was significantly lowered by finite element analysis [1]. A massive rotational failure [3] transformed into a debris flow that wiped out 435 to 500 m of the railway line and dammed the Ijai River [2].

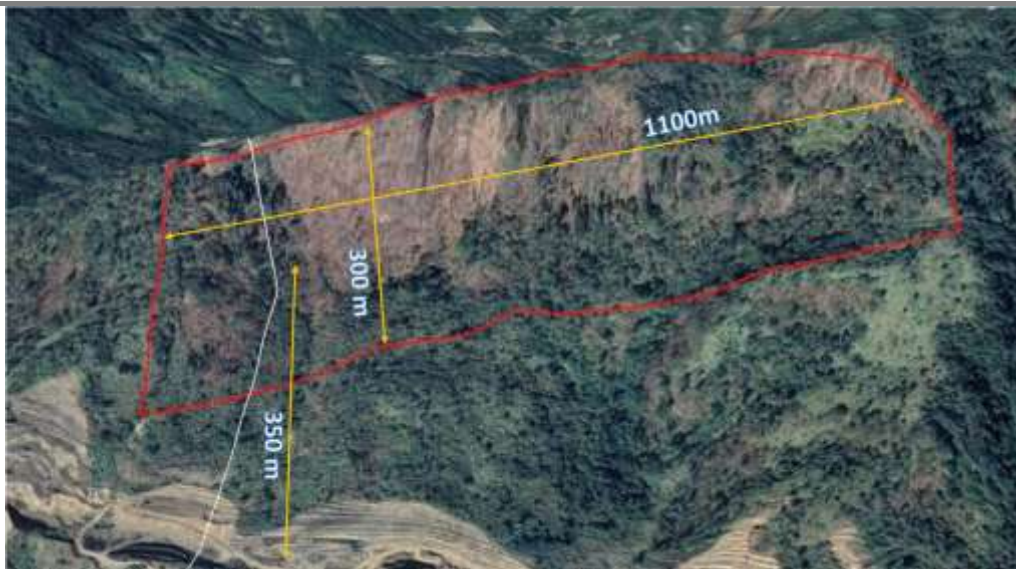
Figure 4: Pre-development Google Earth Satellite Imagery.

Description: A prominent landslide scarp, approximately **1,100 meters** in length and **300 meters** in depth, is located roughly **350 meters** upslope from the project site.

Recent investigations have revealed that the Tupul disaster was not a new event but a major reactivation of an extensive ancient landslide [1], [3]. A dormant scarp about 1,100 meters long and 300 meters deep was located about 350 meters above the project site [1]. These geomorphological features correspond to areas of rock fracture and "relict" soil masses that are permanently weakened and highly prone to failure under saturated conditions [1], [3].

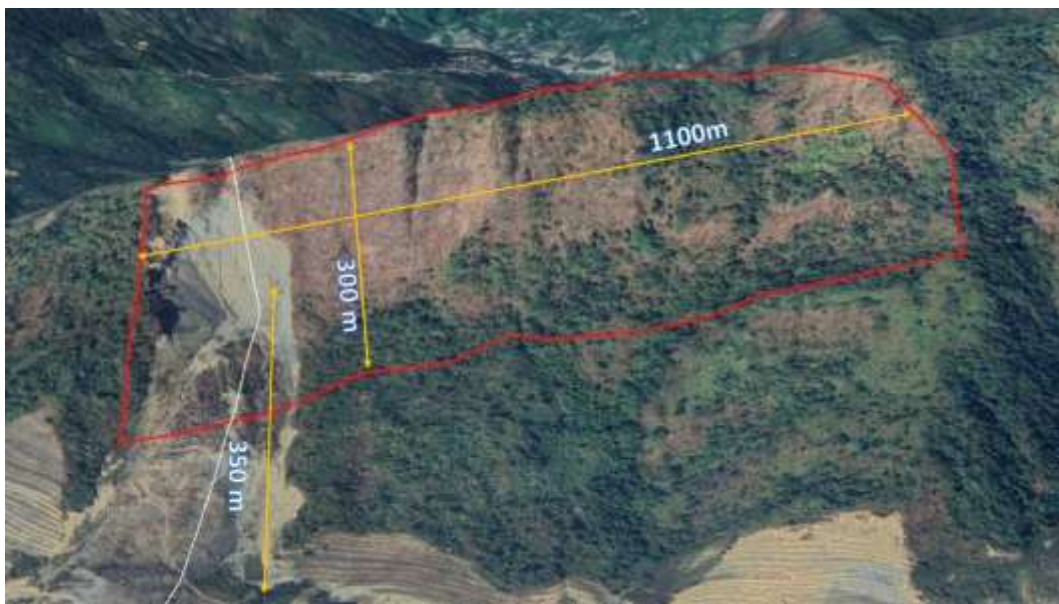
Figure 5: Post-event Google Earth Satellite Imagery.

Description: The landslide scarp remains intact and represents a significant ongoing hazard for future slope failure. Any proposed construction in the vicinity must undergo rigorous geotechnical review and risk assessment due to the proximity of this **1,100-meter-long** and **300-meter-deep** feature, located **350 meters** upslope from the site.

This is a serious flaw: many infrastructure projects in mountainous regions restrict stability analysis to the immediate footprint of the project, while for any project in a landslide-prone corridor, analysis should extend to the surrounding geomorphological environment. The 1100-meter scarp uphill from the station was a "ticking time bomb" that was outside the standard site-specific investigation zone. Additionally, while 37% of the Imphal-Jiribam corridor had been mapped as medium to high susceptibility in regional mapping [4], there was a disconnect between academic hazard mapping and engineering execution, a common trend in the literature reviewed [3].
